Multifaceted ground water quality and recharge mechanism issues in a mega-city (Rawalpindi, Pakistan), and mitigation strategies

LT. COL. ISLAM-UL-HAQ TI (M) R¹, W.A. CHEEMA² & CH. NASEER AHMED³

1 Managing Director, Water and Sanitation Agency, Liaquat Bagh Murree Road, Rawalpindi, Pakistan
islamhaq3@yahoo.com

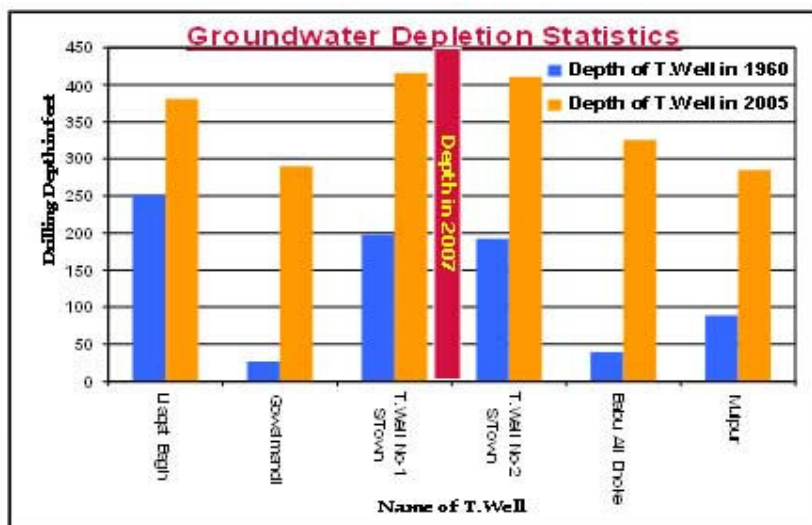
Fig- 3.1 Statistics on Ground Depletion in Rawalpindi- Pakistan

a. **Water Table Depletion**

Year wise comparison of water table depletion matrix is shown in figure-3.1, below, which is approximately observed @ of 10 ft per year;

11. During the course of research, following have observed;
 - a. The rate of extraction of ground water (120 MGD) is much more than the recharge. Virtually there is no planned recharge mechanism in place, therefore, the aquifer depletion rate is about 10 feet/year. Hence, due to this phenomenon, there can be a big environmental disaster in the city of Rawalpindi-Pakistan.

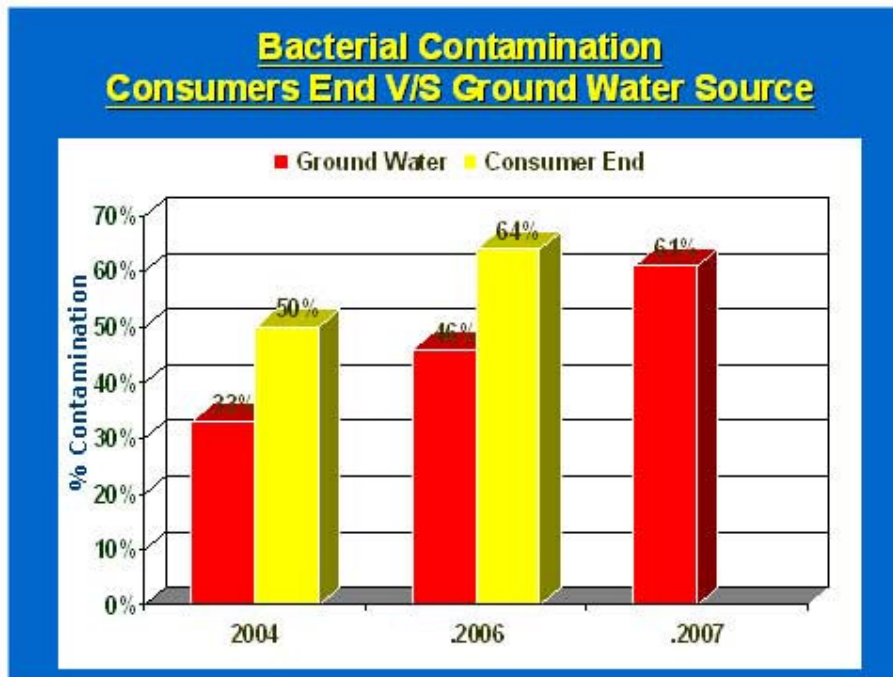
Fig. 3.2 Comparison between bacterial contamination- source v/s consumer's end

With this fast depletion of aquifer, the contamination level both at source and at consumer's end has increased beyond the acceptable limits. Figure-3.2, below, shows the trend in increase of contaminations;

- b. Over extraction of ground water has exposed the upper aquifer, thus causing bacterial contamination at a faster rate. About 50% tube well now producing contaminated water verses 33% in 2003.

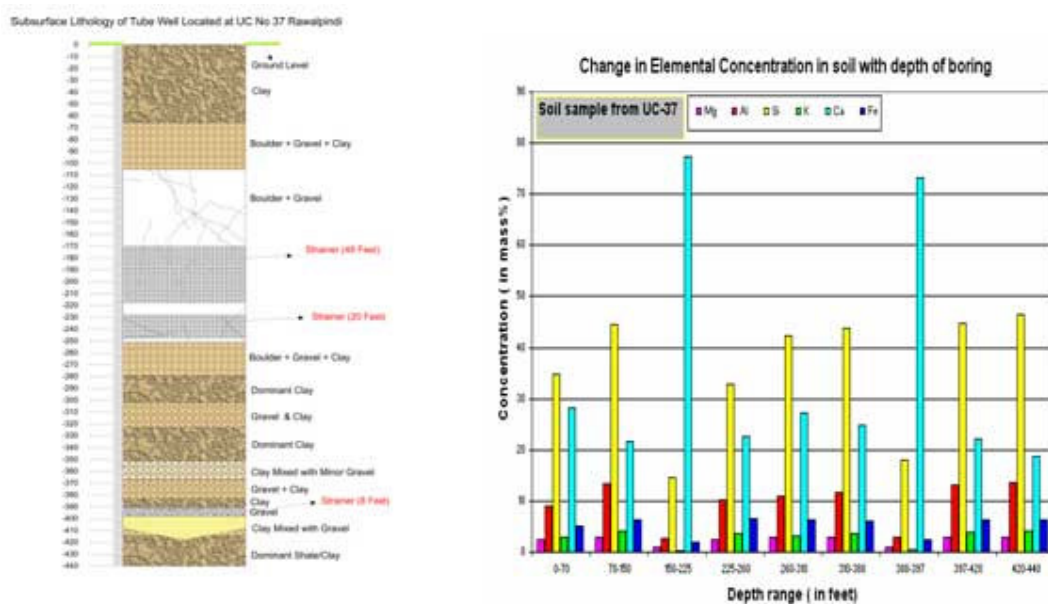
fig. 5.1 Geo – Chemical analysis of soil strata of Tube well-37 near bank of Nallah Lai

5. Geo-chemical investigation of soil strata of two tube wells were carried out with energy dispersive X-Ray fluorescence spectrometer (XRF) equipment. The logging and XRF analysis are shown in fig. 5.1 and 5.2 below;

- c. Most of the un-treated domestic wastewater flowing in open drains is also contributing towards ground water bacterial contamination.
 - d. Geo-chemical analysis of soil strata has shown some traces of heavy metals, which may be polluting ground water chemically as well.

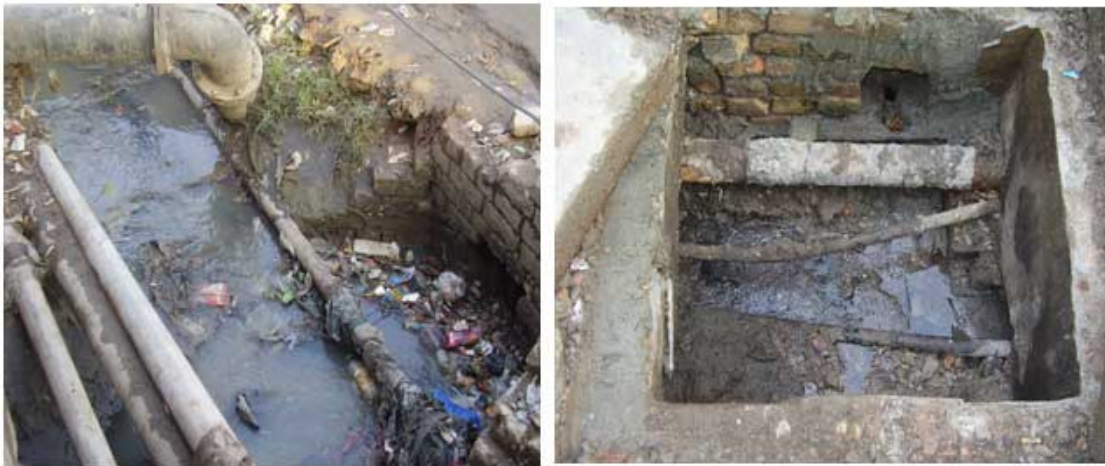
Fig. 8.1: Hand in gloves laying of drinking water distribution pipe lines with sewerage drains.

8. Most of the distribution net work lines are passing through sewerage drains which are causing contamination at consumer’s end. The other factors responsible for contamination are as under;

- a. Non-existence of legislation on ground water extraction
- b. Imbalance/ill-planned/Un-documented Distribution Network
- c. Un-regulated / Non-metered / Non-judicious water supply
- d. Major Leakages in Feeding mains (Old PRCC Pipe lines)
- e. Hand-in-gloves laying of drinking water and sewerage lines-contaminant intrusion route, as shown in figure-8.1
- f. Installation of unauthorized suction pumps by consumers – major cause of contamination.
- g. Un-Authorized Installation of water connection & without approved ferrule size- In Commercial Plazas
- h. Bacterial contamination in Ground water
- i. Contamination in Filtration Plants installed by TMA
- j. Poorly maintained Chlorination/Disinfection System.

- a. Installation of hypo chlorinators on contaminated tube wells.
- b. Re-routing of the distribution lines away from the sewerage drains and replacing the damaged / rusty water pipe lines.
- c. Managing the wastewater by constructing nodal system of wastewater treatment plants
- d. Constant water quality monitoring
